Figure A6.1: Tree survey photographs

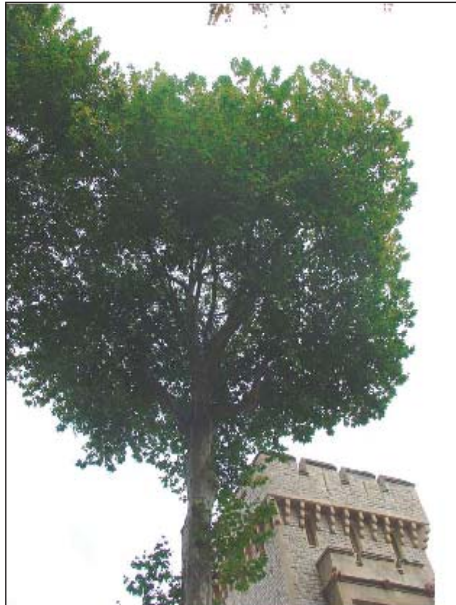
Photograph 1
The crown of T138 that may respond well to crown restoration

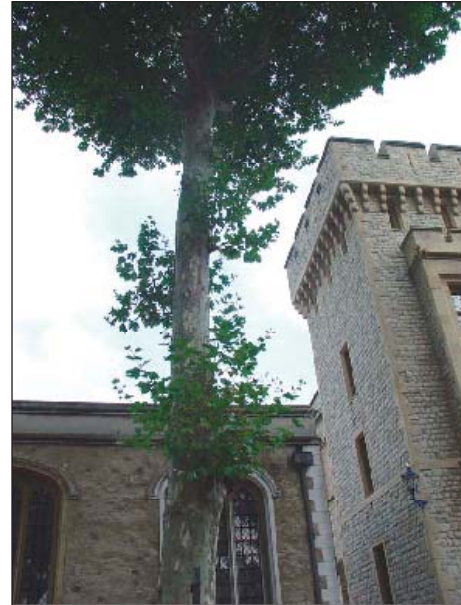
Photograph 2
Epicormic growth on T138

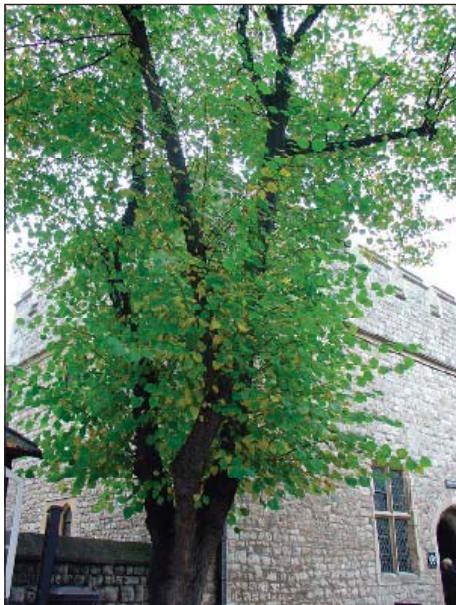
Photograph 3
Dense epicormic growth on T147

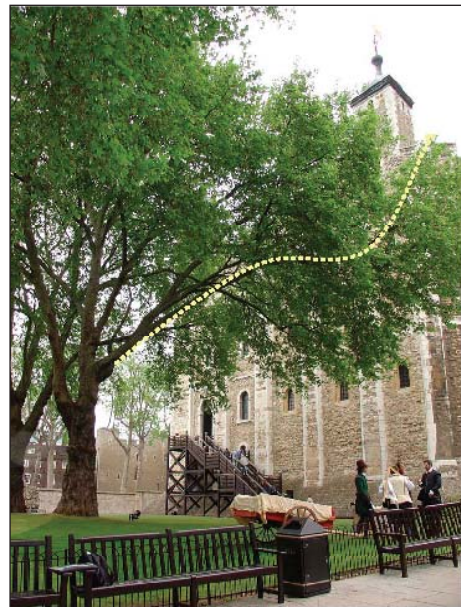
Photograph 4
End-loaded limb on T132 – yellow dashed line

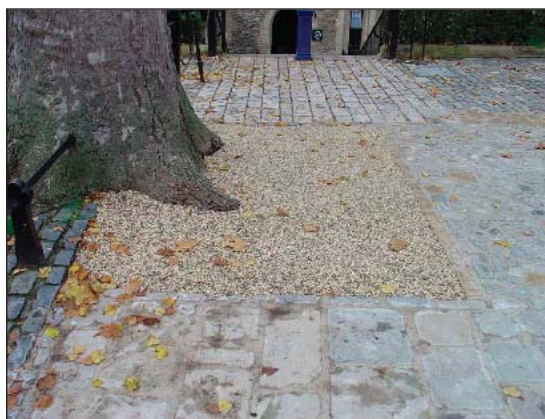
Photograph 5
Resin-bonded gravel at the base of T141

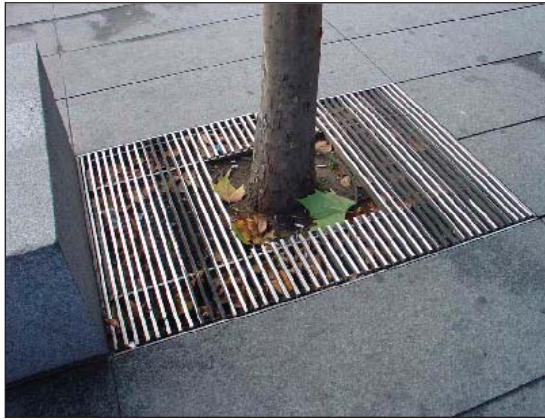
Photograph 6
Planting pit with metal grill around one of the trees in the new entrance/information area – Trees 22 to 26

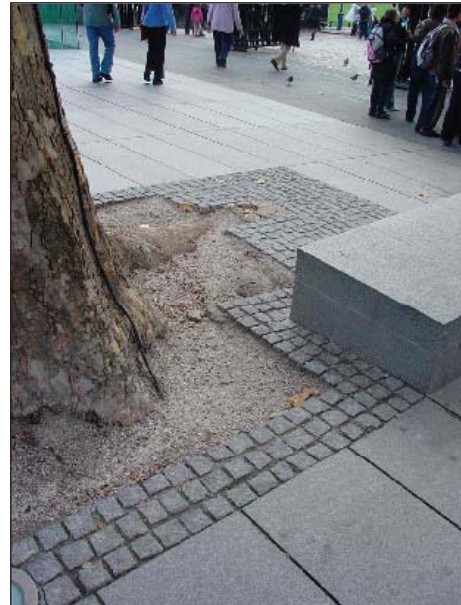
Photograph 7
Surface treatment around the base of T100

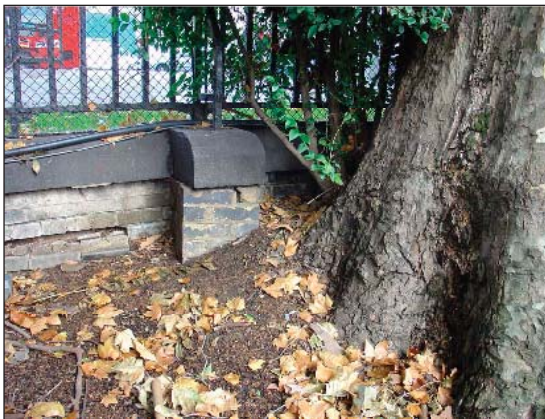
Photograph 8
T153 causing direct damage to the adjacent wall

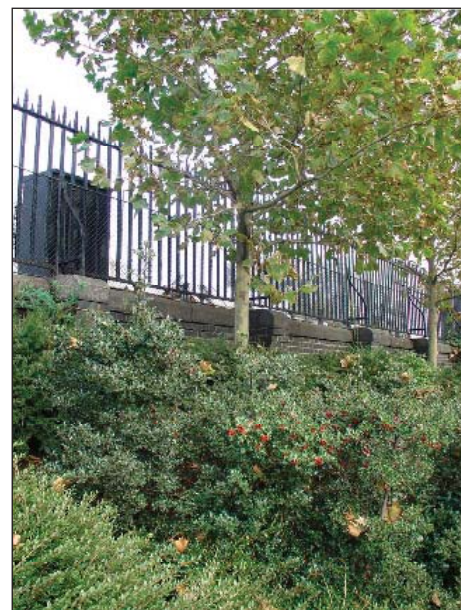
Photograph 9
Showing proximity of new planting on the Moat Banks to the perimeter wall and railings
